System 1100 Wet Seal Attachment System Details with Mineral Wool Insulation

Revised 11/2020

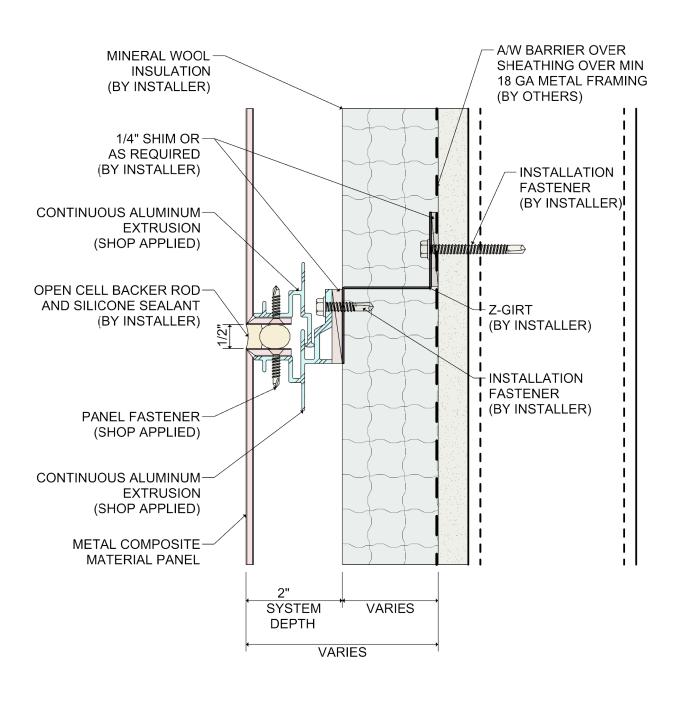
SYSTEM 1100

HORIZONTAL JOINT

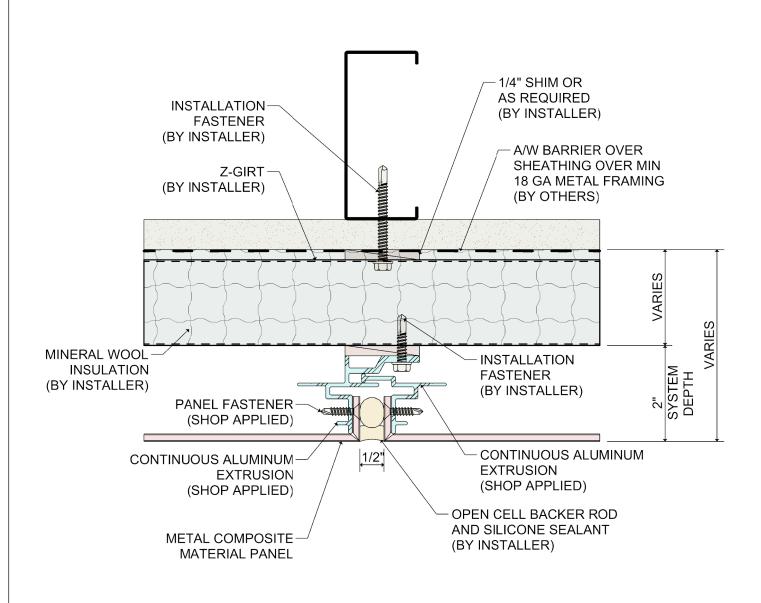
DETAIL: SYSTEM 1100 WET SEAL SYSTEM

VERTICAL JOINT

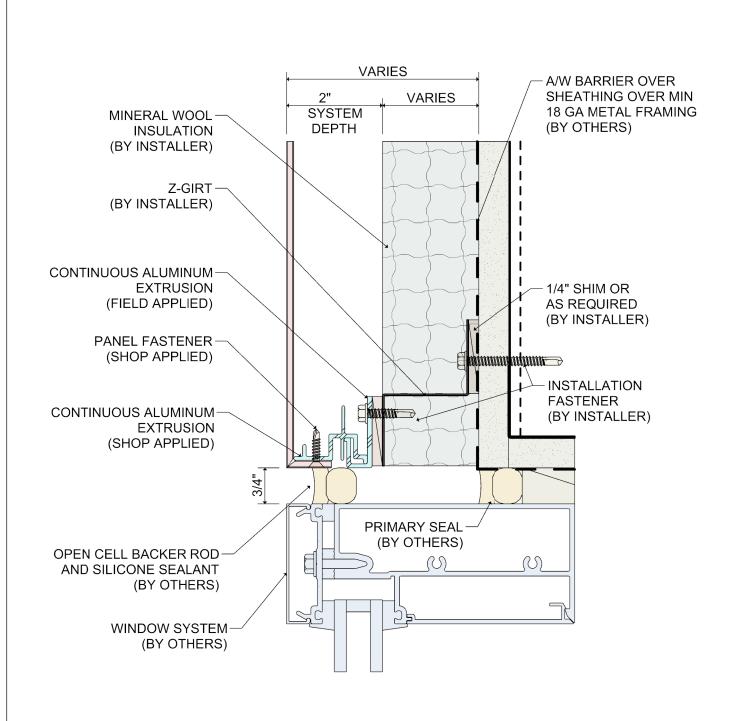
WET SEAL SYSTEM **SYSTEM 1100** DFTAIL: WINDOW HEAD DETAIL

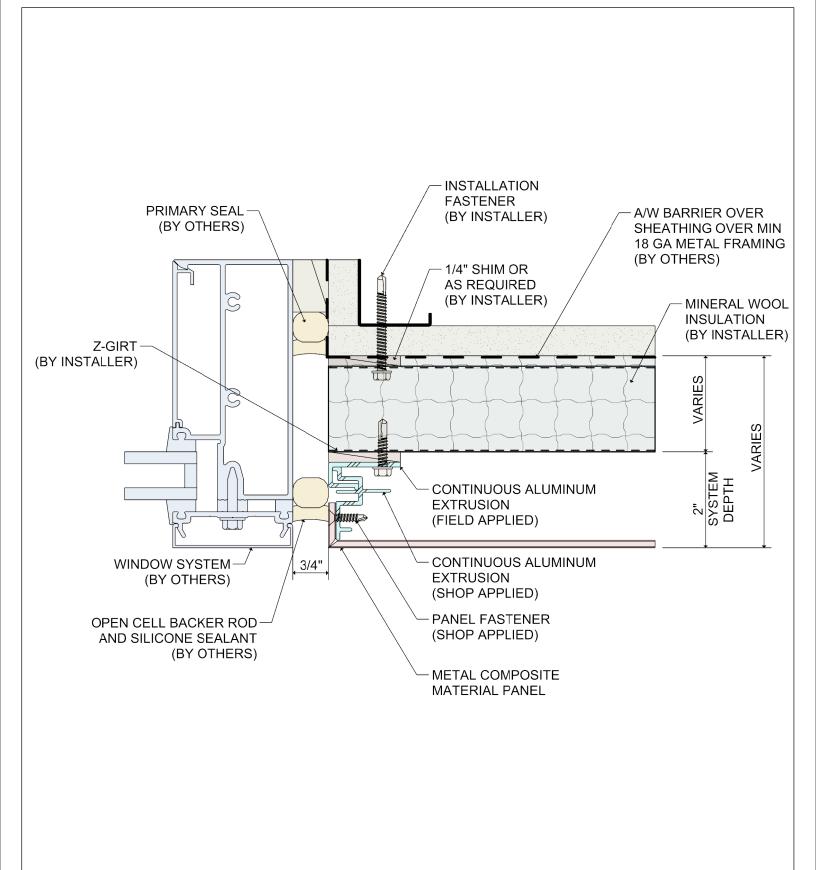
SYSTEM 1100

WINDOW JAMB DETAIL

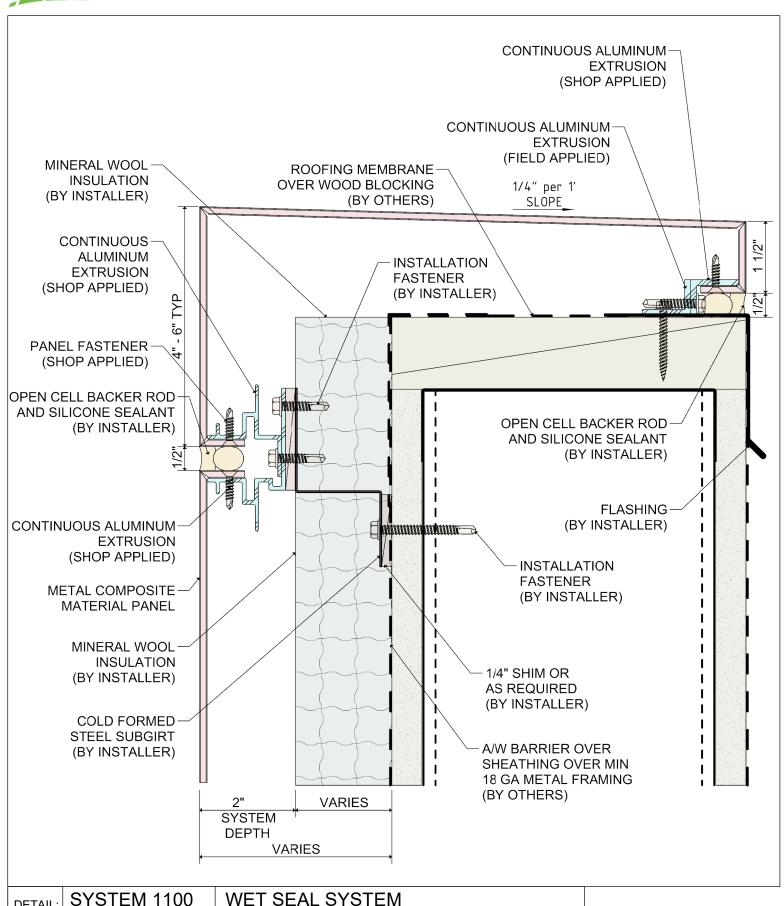
METAL COMPOSITE MATERIAL COPING DETAIL

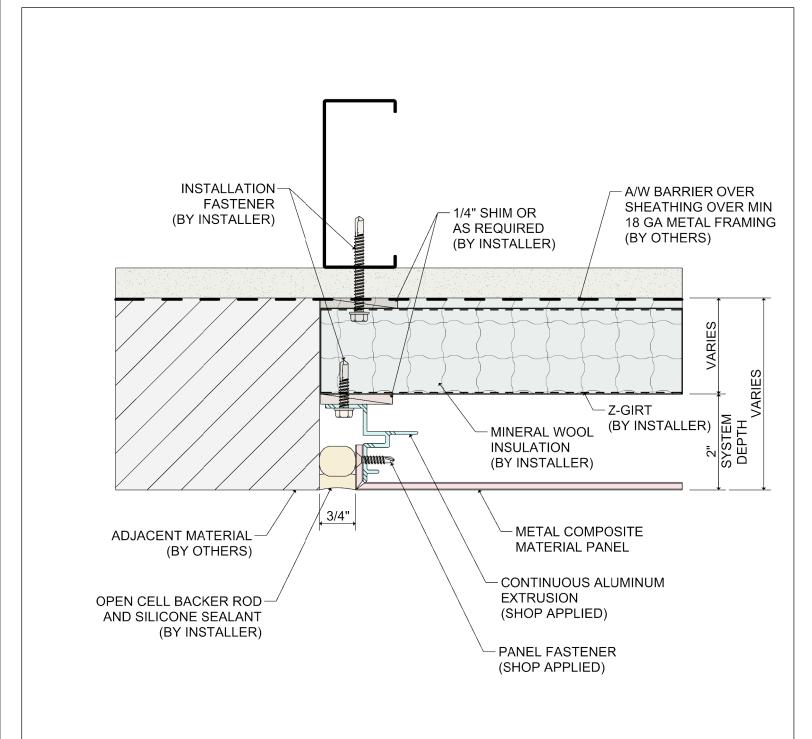
DETAIL:	SYSTEM 1100	WET SEAL SYSTEM
9	VERTICAL JAMB DETAIL

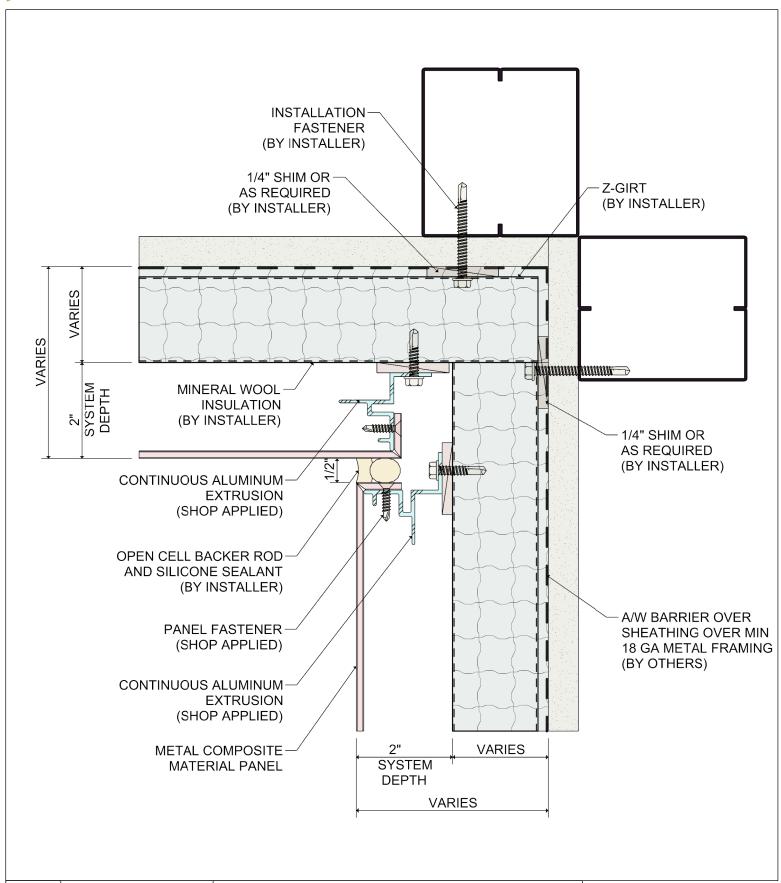
SYSTEM 1100 WET SEAL SYSTEM

INSIDE CORNER DETAIL

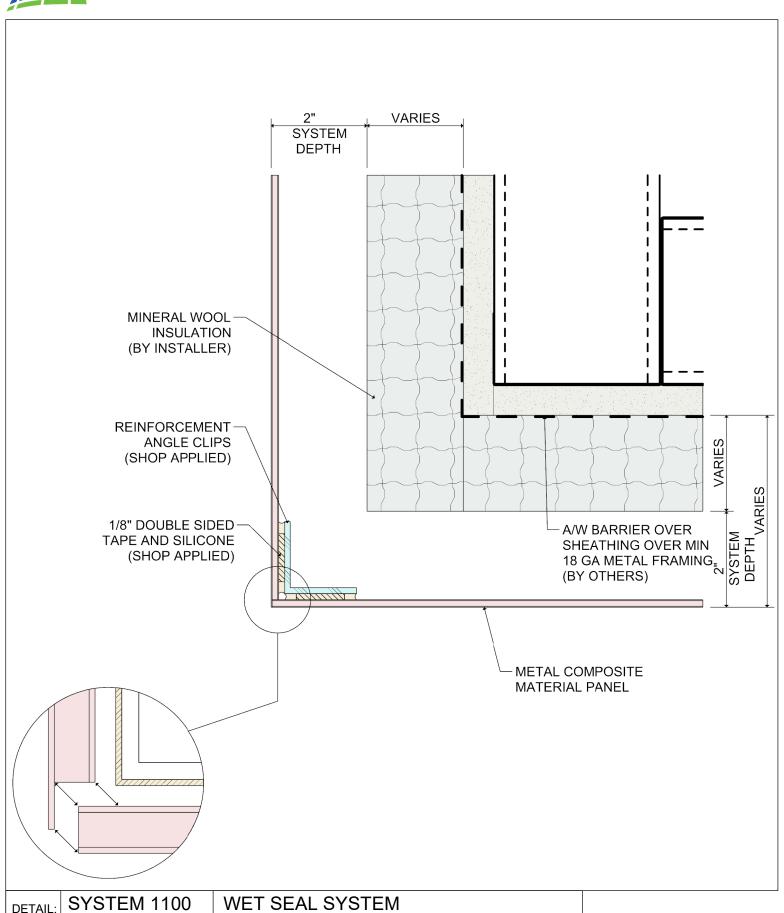
HEM JOINT DETAIL

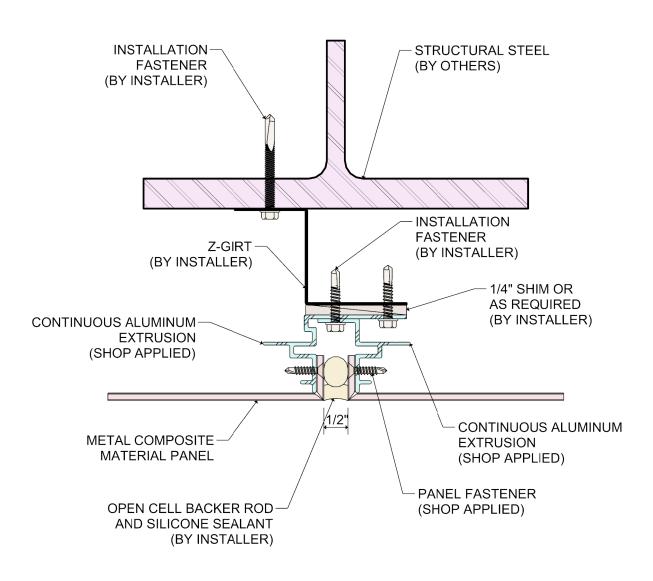
SYSTEM 1100 WET SEAL SYSTEM

RECTANGULAR COLUMN DETAIL

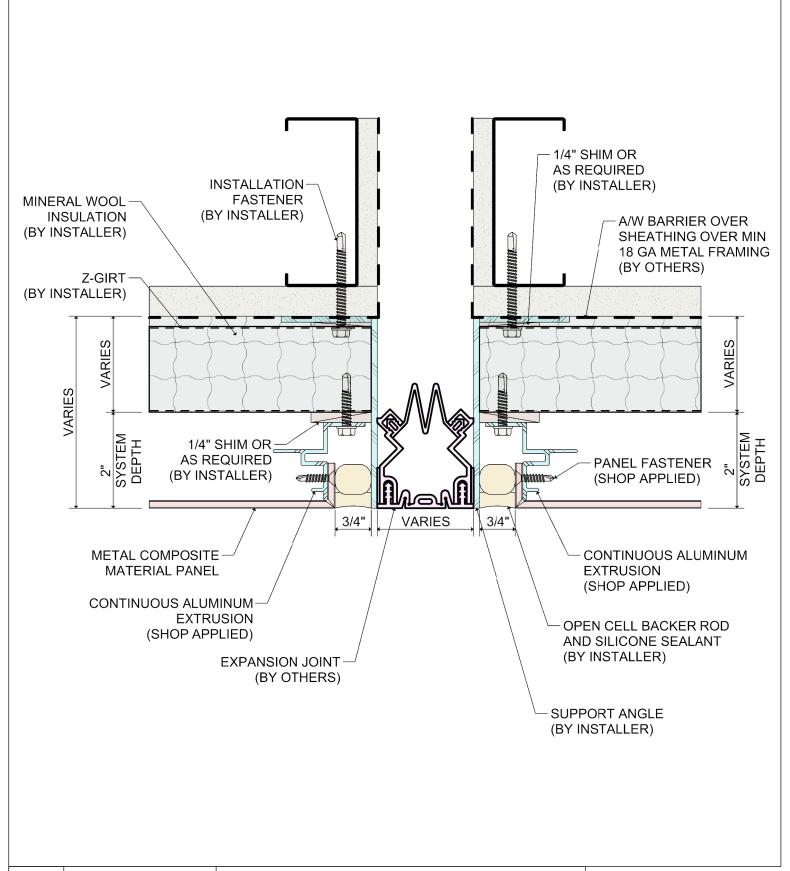
SYSTEM 1100 | WE

JAMB AT EXPANSION JOINT

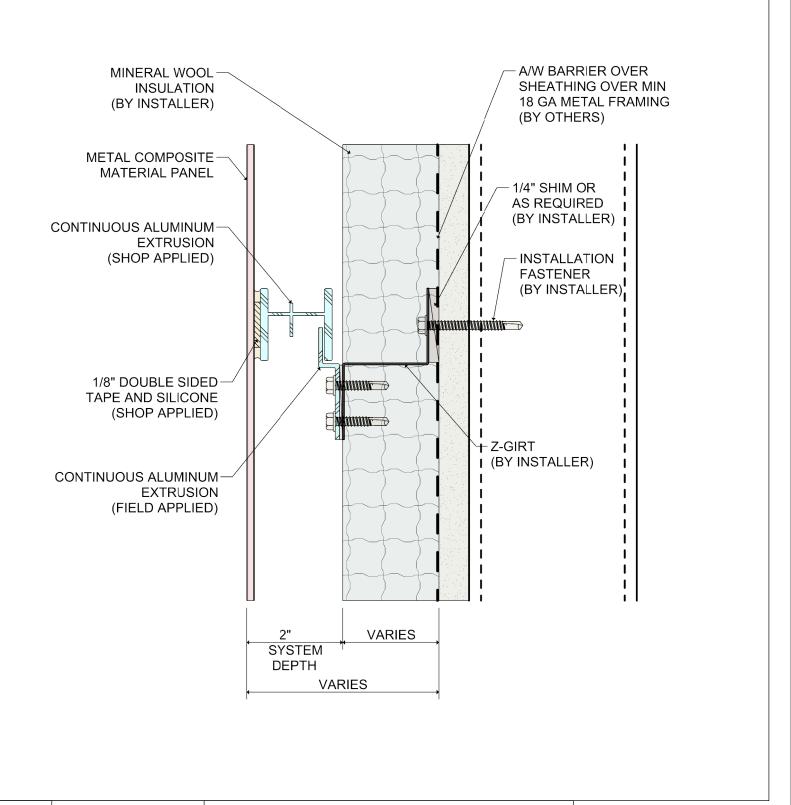
SYSTEM 1100 WET SEAL SYSTEM

RETAINER EXTRUSION DETAIL
